# Geospatial Technologies and Human Rights Project

Monitoring Change in Sri Lanka's Valikamam  
High Security Zone: 2009-2014

August 2014

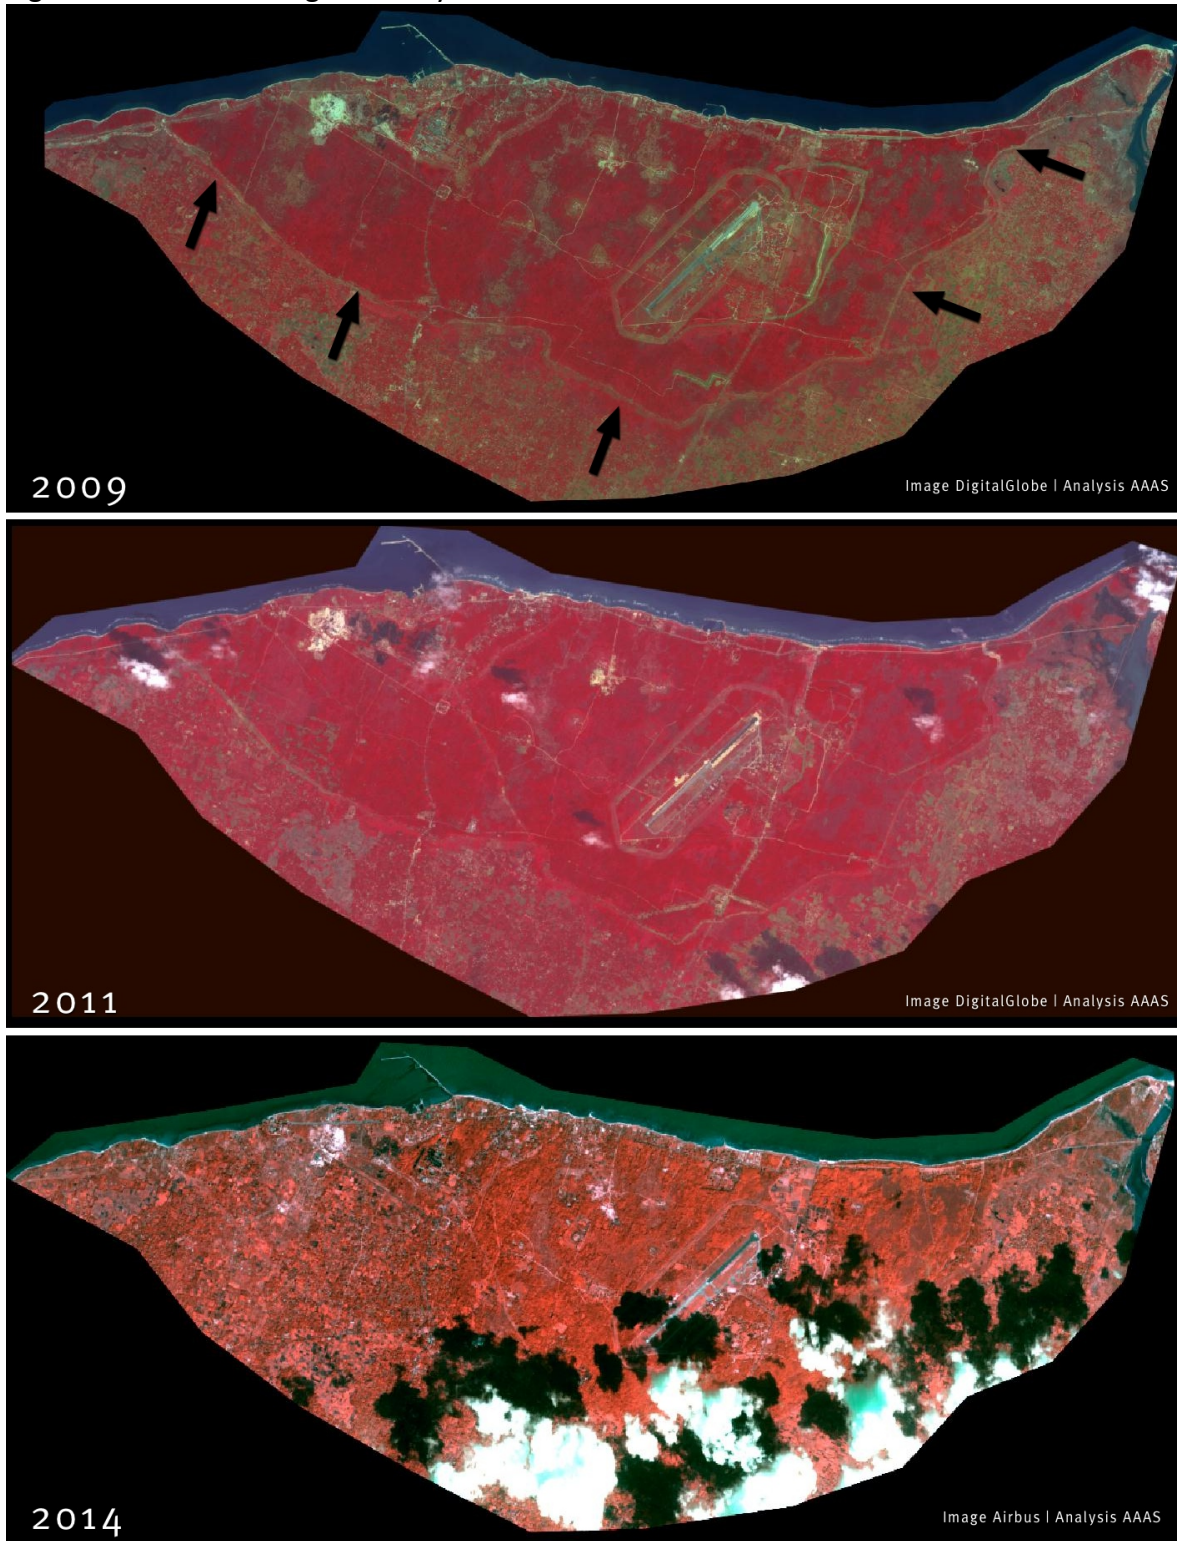
Figure 2: Valikamam High Security Zone

*The border of the HSZ being retained by the Sri Lankan government is clearly seen in the first and second images (2009 and 2011) as a line (black arrows) separating the more heavily vegetated and less developed military zone from the areas surrounding it. By 2014, however, development has clearly occurred within the military zone.*

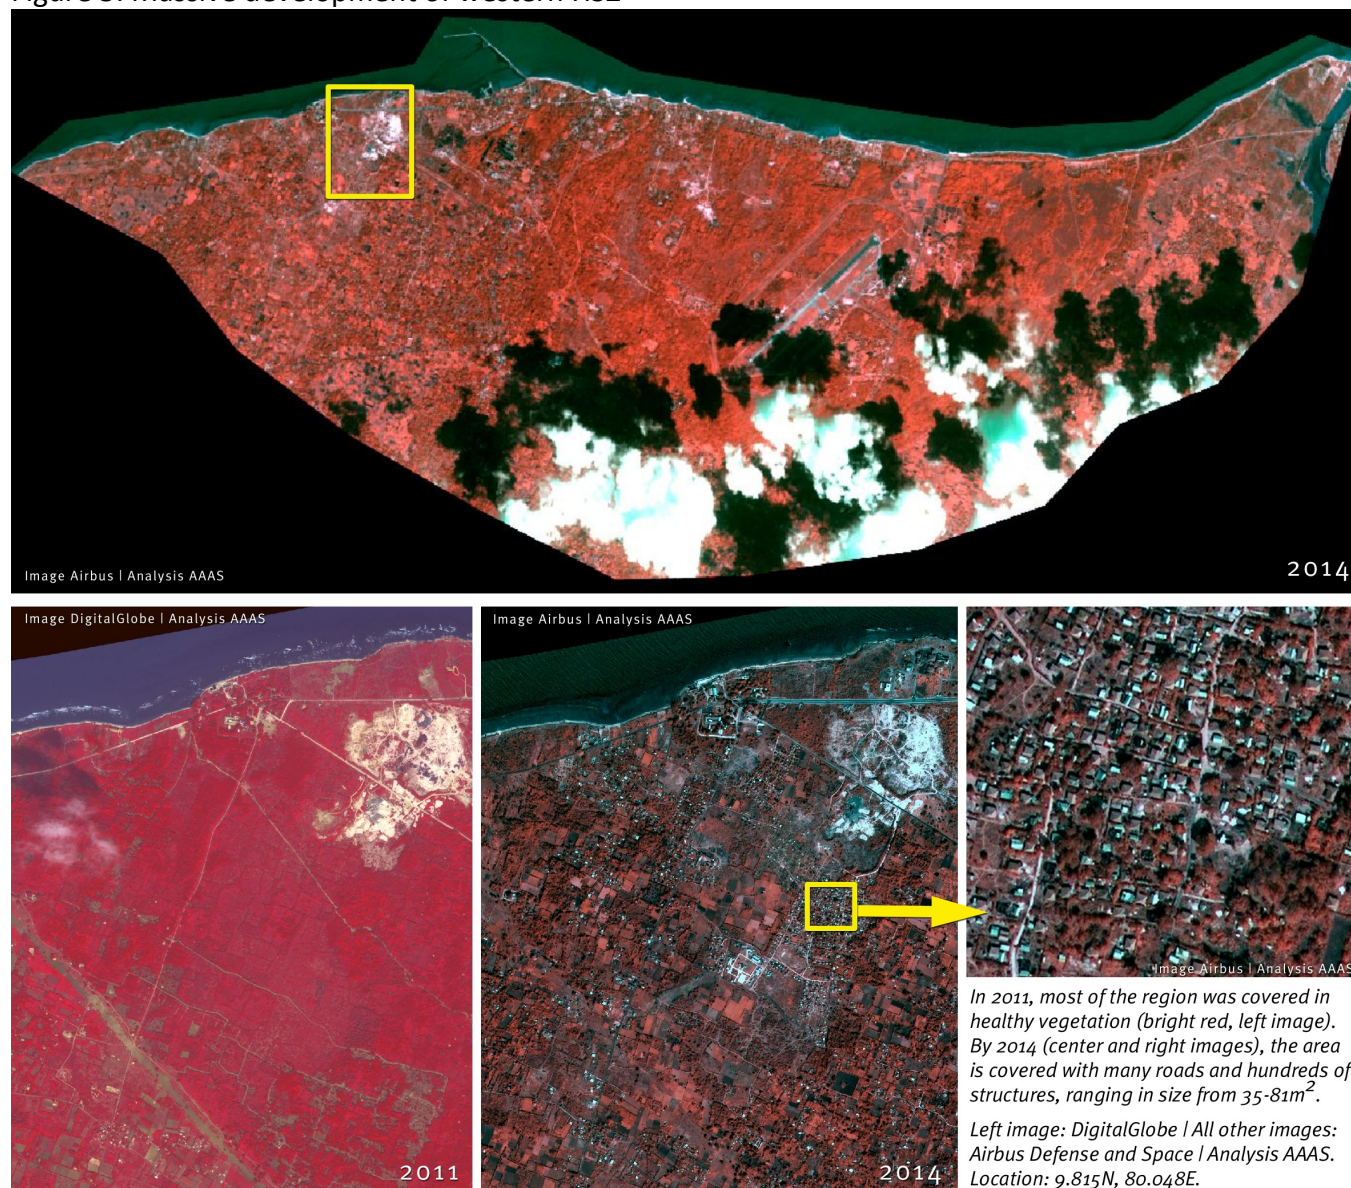
Figure 3: Massive development of western HSZ

Between 2011 and 2014, the landscape in the western half of the military zone changed dramatically. As can be seen in the enumeration of results reported in Table 2, extreme growth in the number of structures was observed in the time period of 2011-2014 within the HSZ (Figure 3). Hundreds of new structures of various sizes were constructed during this time period.

The observed development occurred between 2011 and 2014 within the entire western portion of the HSZ and covered approximately 6.5km<sup>2</sup>. Structures have been constructed all the way to the former edge of the zone and the border road is no longer obvious by 2014 (Figure 4).

Between 2011 and 2014, the number of structures in the area increased from approximately 550 to over 2,700.

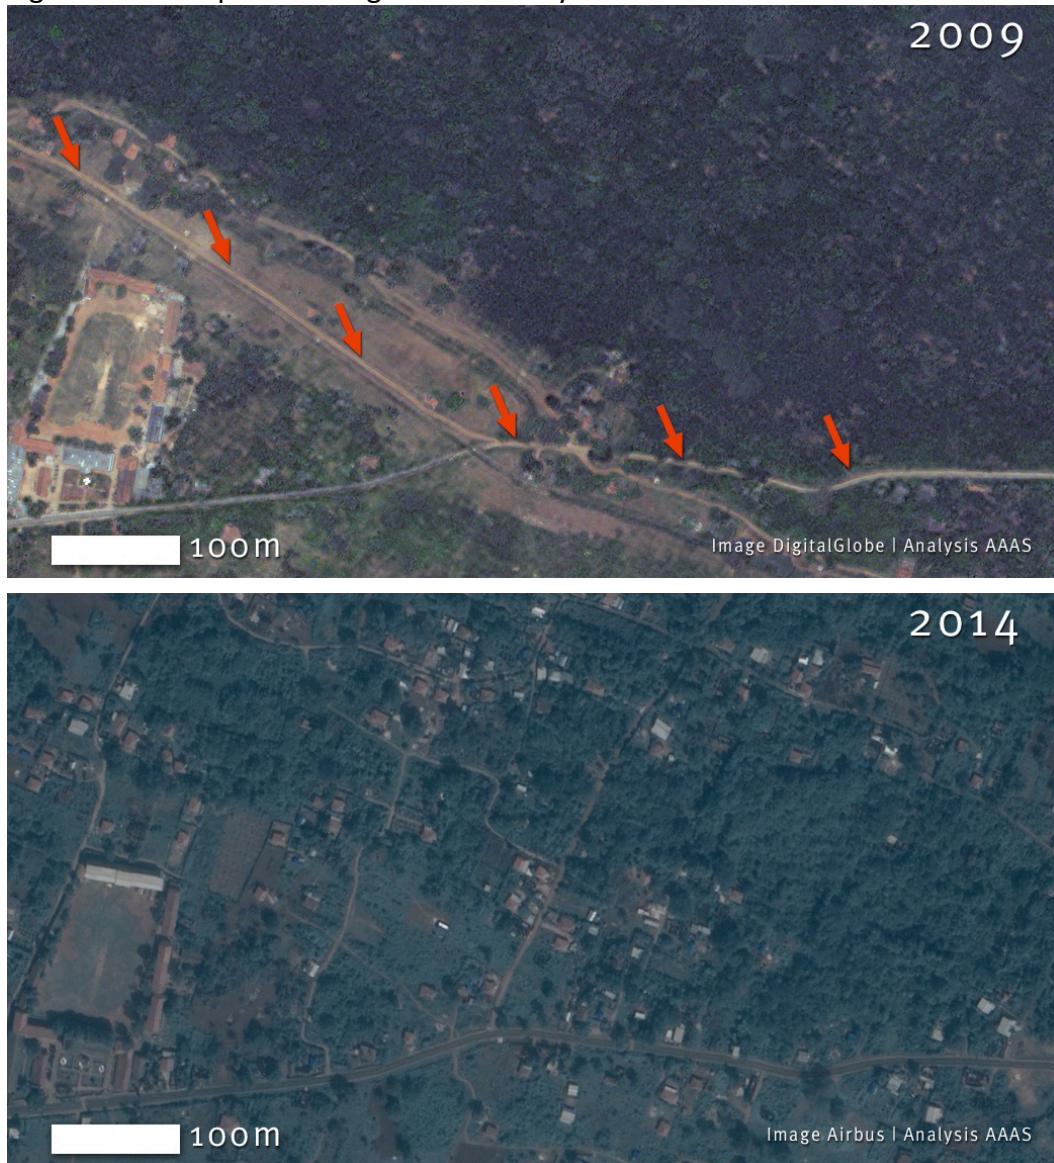
Figure 4: Development along HSZ boundary

*In 2009 (top image), the HSZ border is clearly visible (red arrows). By 2014 (bottom image), the boundary has been obscured by the development of dozens of small structures and multiple new roads. Top image: DigitalGlobe | Bottom Image: Airbus Defense and Space | Analysis AAAS. Location: 9.815N, 80.048756E.*

At the request of the Sri Lanka Campaign for Peace and Justice, the AAAS Geospatial Technologies and Human Rights Project examined the area known as the Valikamam High Security Zone over the period of 2009-2014. This HSZ, located on the northernmost point of the country, on the Jaffna Peninsula, has been under military control for several decades. AAAS investigated changes within the zone since the end of the 2009 military conflict. Specifically, AAAS aimed to assess claims by the SLC that the area was being developed outside the scope of military usage, particularly in light of assertions from former residents that they are unable to return to their former lands. AAAS observed a number of changes in the Zone during the study period relating to land use. The most obvious change was a dramatic increase in housing-style structures, particularly between 2011 and 2014 (Figure 3). This led to a lack of clarity regarding the delineation of the border between the HSZ and civilian areas (Figure 4).

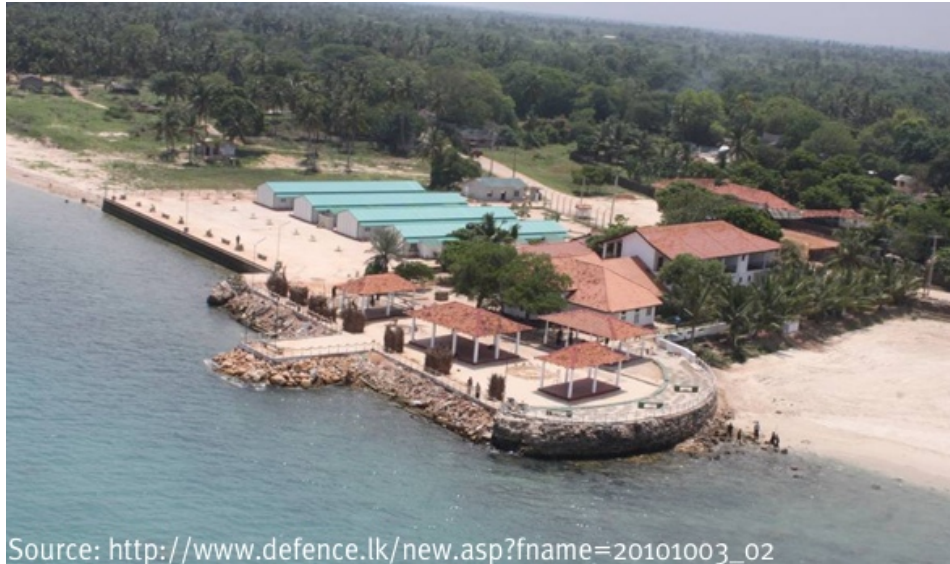
Figure 5: Thalsevana Holiday Resort

5 and 6).<sup>8</sup> As noted on the resort’s website, “THALSEWANA HOLIDAY RESORT functioning under the Security Forces Headquarters – Jaffna provides you an ideal venue to make your holiday perfect and memorable.” The resort’s website even contains a Google Earth map marking its location.<sup>9</sup>

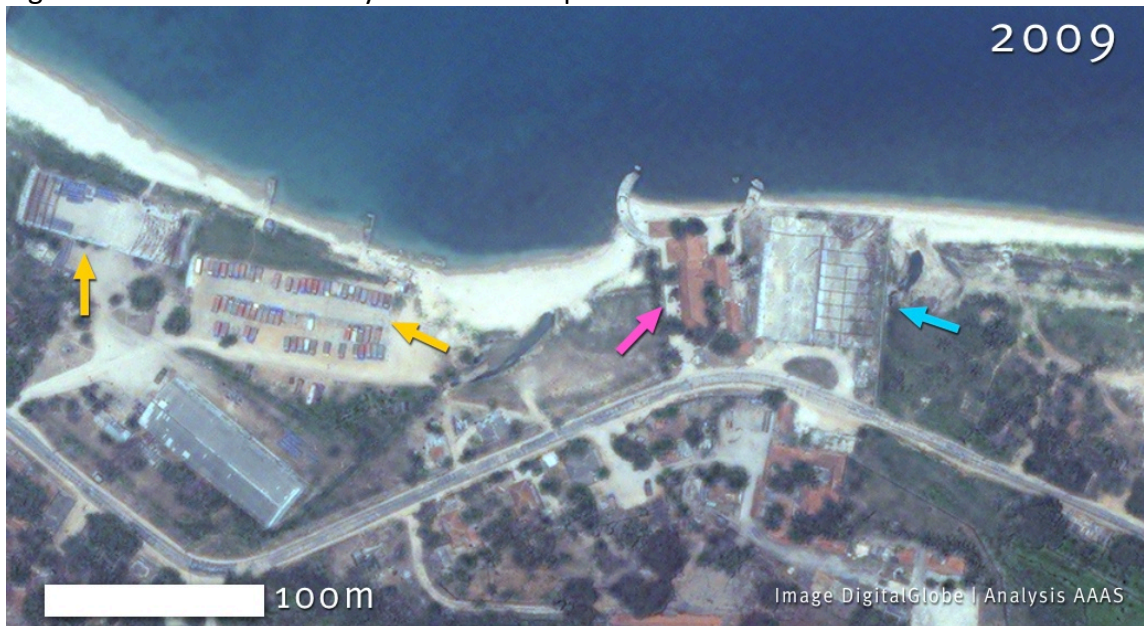
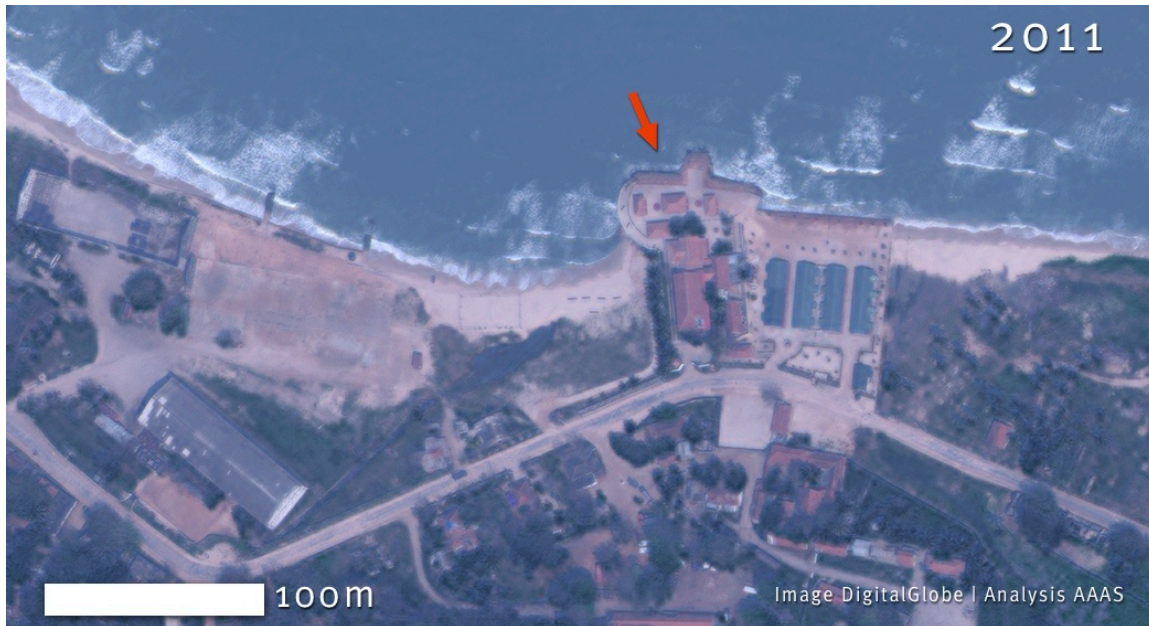
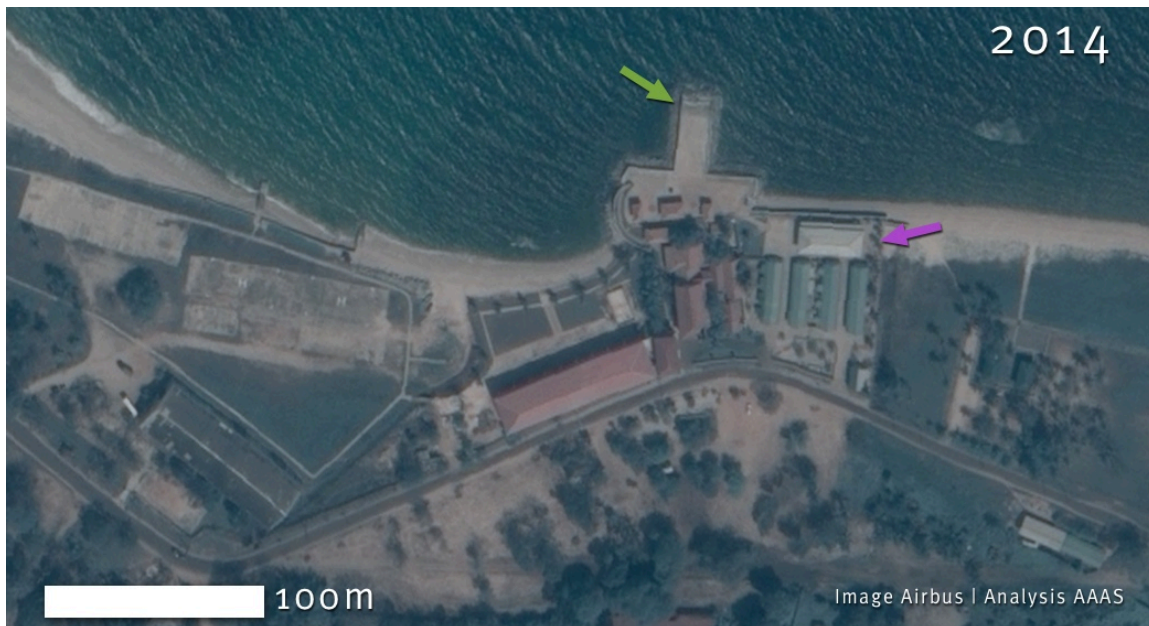
Figure 6: Thalsevana Holiday Resort development

*In 2009, the main building of the Thalsevana Resort is already constructed (pink arrow), while additional buildings are under construction (blue arrow), and numerous shipping containers are seen adjacent to the site (yellow arrows). By 2011, the buildings previously under construction have been completed, and an area along the beach is being built out into the ocean (red arrow). Finally, by 2014, one additional large building has been added to the site (purple arrow) along with several smaller buildings, and the expansion into the ocean has continued (green arrow). Top and middle images: DigitalGlobe| Bottom Image: Airbus Defense and Space | Analysis AAAS. Location: 9.815N, 80.048756E.*

In addition to the construction of hundreds of individual structures, several areas along the coast were developed, including several reported luxury resorts.<sup>7</sup> While one of the resort developments along the coast could not be delineated from other large-scale developments, such as was seen in Figures 7 and 8, the Thalsevana Holiday Resort at Kaankeasan-thu'rai was identified. The Thalsevana Holiday Resort been highly touted by the Sri Lankan Military (Figures

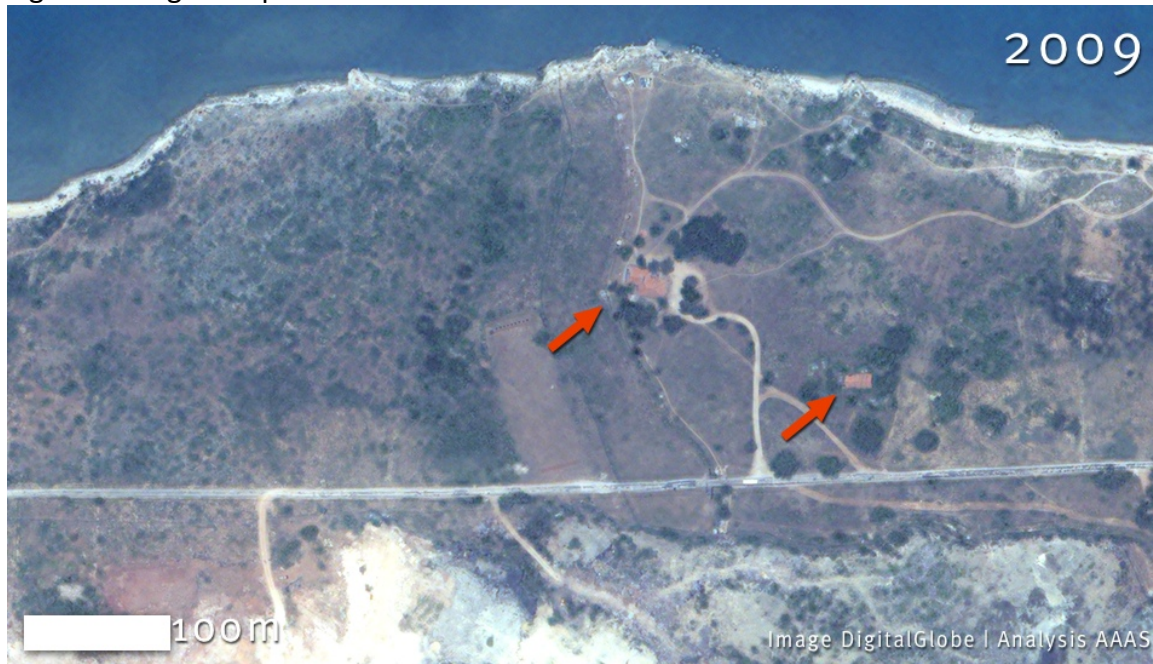
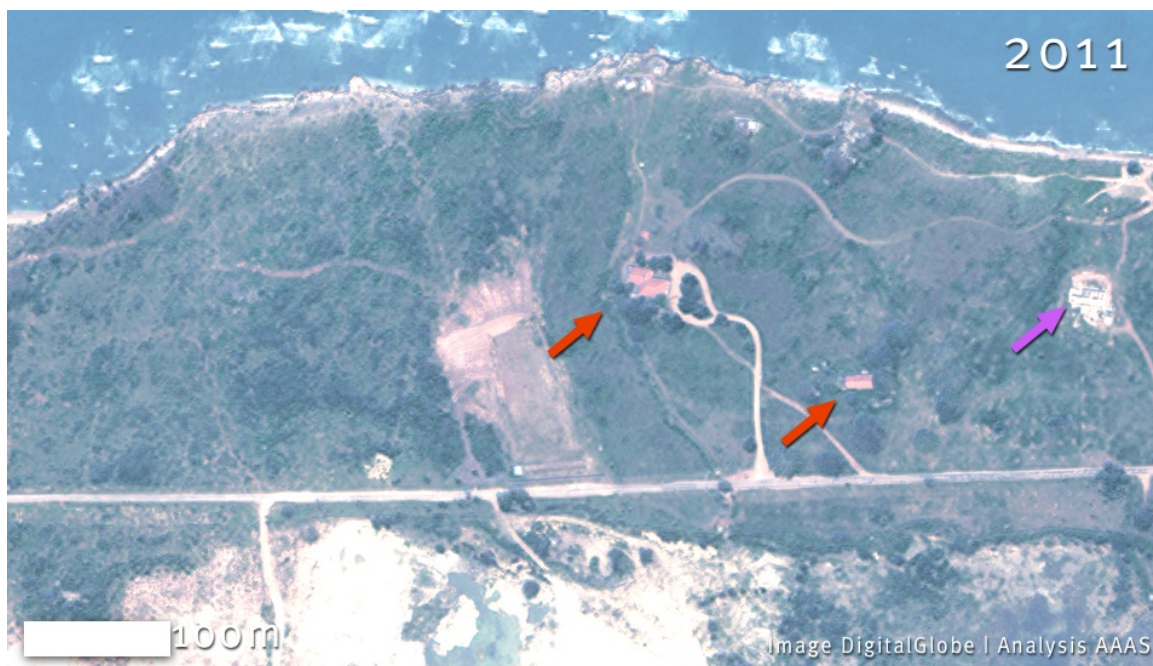
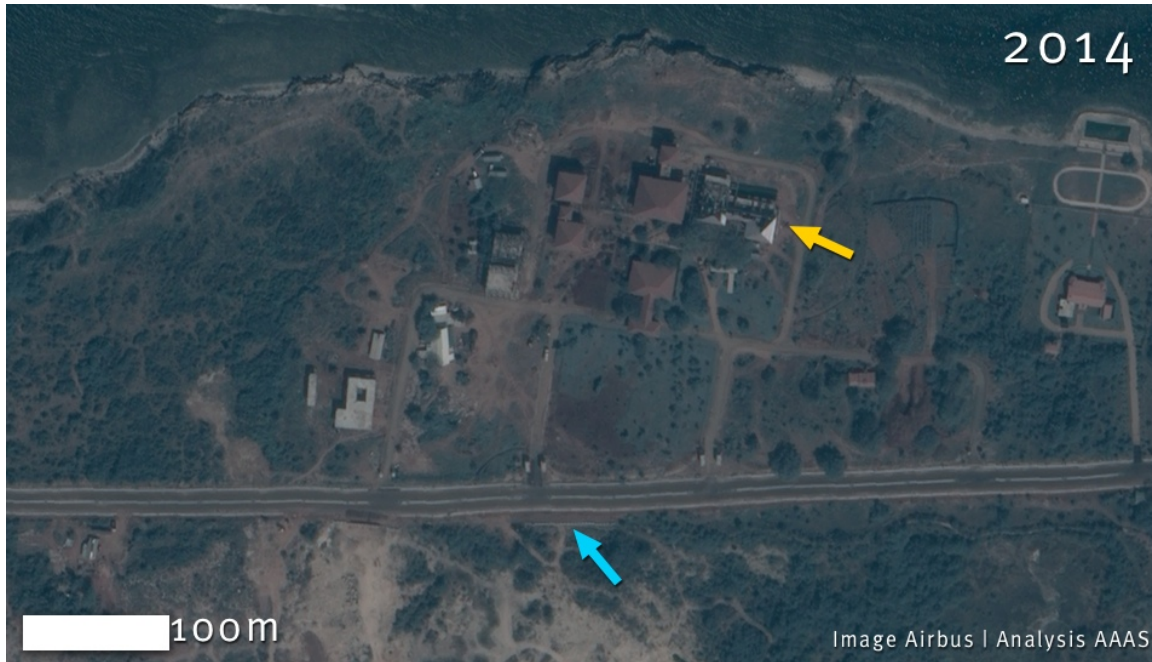
Figure 7: Large complex constructed between 2011-2014

At another location, less than 3km from Thalsevana, another large complex of buildings was constructed between 2011 and 2014 (Figure 7). In the first image, from 2009, only two large buildings are visible in the area, the larger measuring approximately 440m<sup>2</sup> and the smaller approximately 165m<sup>2</sup>. In 2011, in the eastern portion of the image, a large building is seen

under construction. Finally, by 2014, numerous large structures have been built, ranging from 440m<sup>2</sup> to 1,600m<sup>2</sup>.

*At a site near Thalsevana Holiday Resort, only two buildings are visible in 2009 (red arrows, top image). In 2011, an additional building is under constructions (purple arrow, middle image). Finally, between 2011 and 2014, this site changed dramatically (bottom image). The road running east-west below the complex has been expanded substantially (blue arrow), and numerous buildings have been added to the site, including one building under construction that has a footprint of 1,600m<sup>2</sup> (yellow arrow). Top and middle images: DigitalGlobe| Bottom Image: Airbus Defense and Space | Analysis AAAS. Location: 9.815N, 80.021E.*

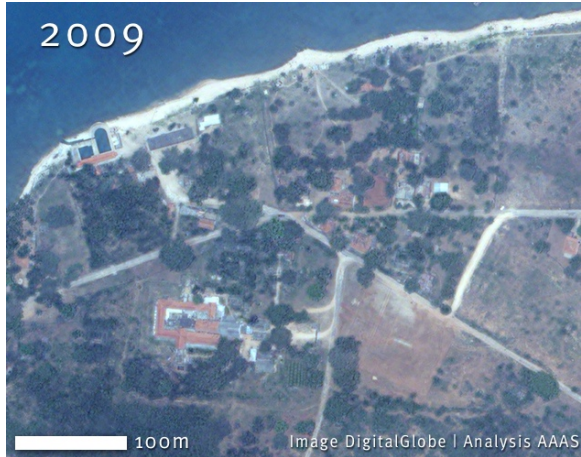
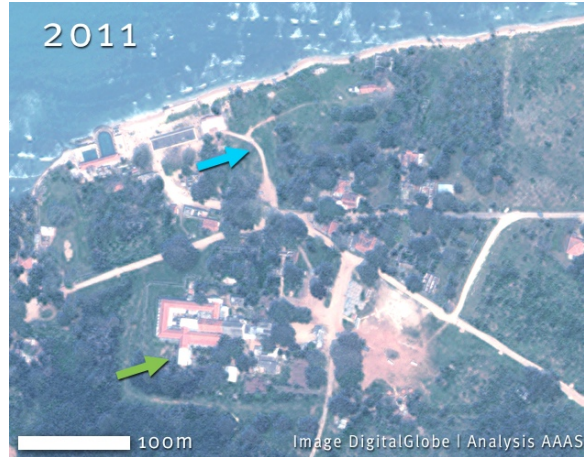
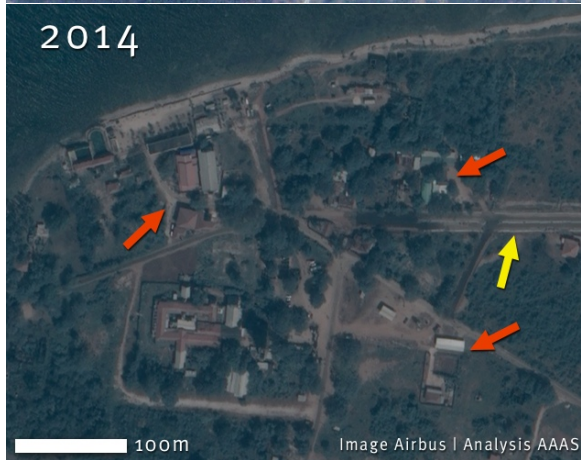
Figure 8: Additional large development along HSZ coast

Another complex, located 1km west of the development in Figure 7 and 4km from the Thalsevana Holiday Resort (Figure 6) shows additional construction (green arrow) and a road (blue arrow). By 2014, several large structures have been added (red arrows) and the main road leading to the complex has been widened and paved (yellow arrow). Top and middle images: DigitalGlobe | Bottom Image: Airbus Defense and Space | Analysis AAAS. Location: 9.815N, 80.011E.

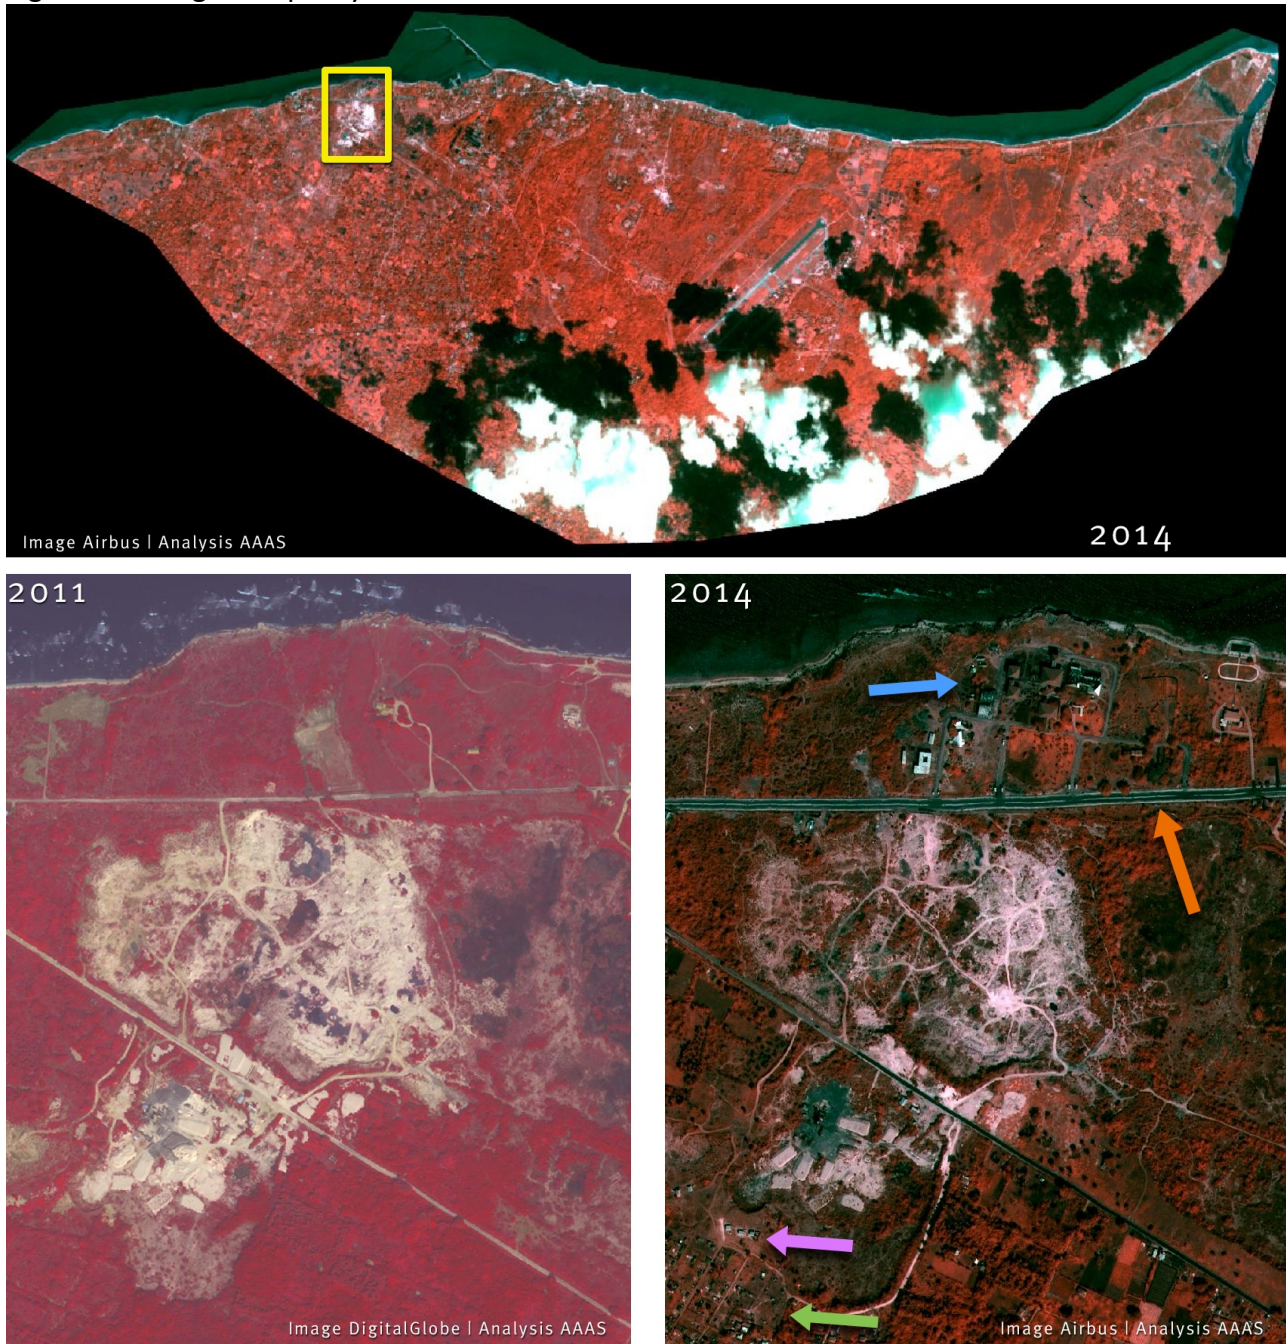
Figure 9: Changes to quarry

Some changes were observed adjacent to a quarry within the HSZ between 2011-2014 (Figure 9), located just south of the large complex detailed in Figure 7. Several buildings were constructed within the site itself, and along the road running just north of the site.

Changes were observed in roads and structures at the quarry area near the northern coast between 2011 and 2014. These images highlight one area, marked by the yellow box in the topmost image. By 2014, additional buildings have been added within the site itself (e.g., purple arrow), as well as several large buildings directly on the coast (blue arrow, also shown in Figure 7), and numerous small buildings to the south of the area. An expansion of the major road running east-west just to the north of the mining area was also observed (orange arrow). Top and right images: Airbus Defense and Space | Left Image: DigitalGlobe | Analysis AAAS. Location: 9.812N, 80.019E.

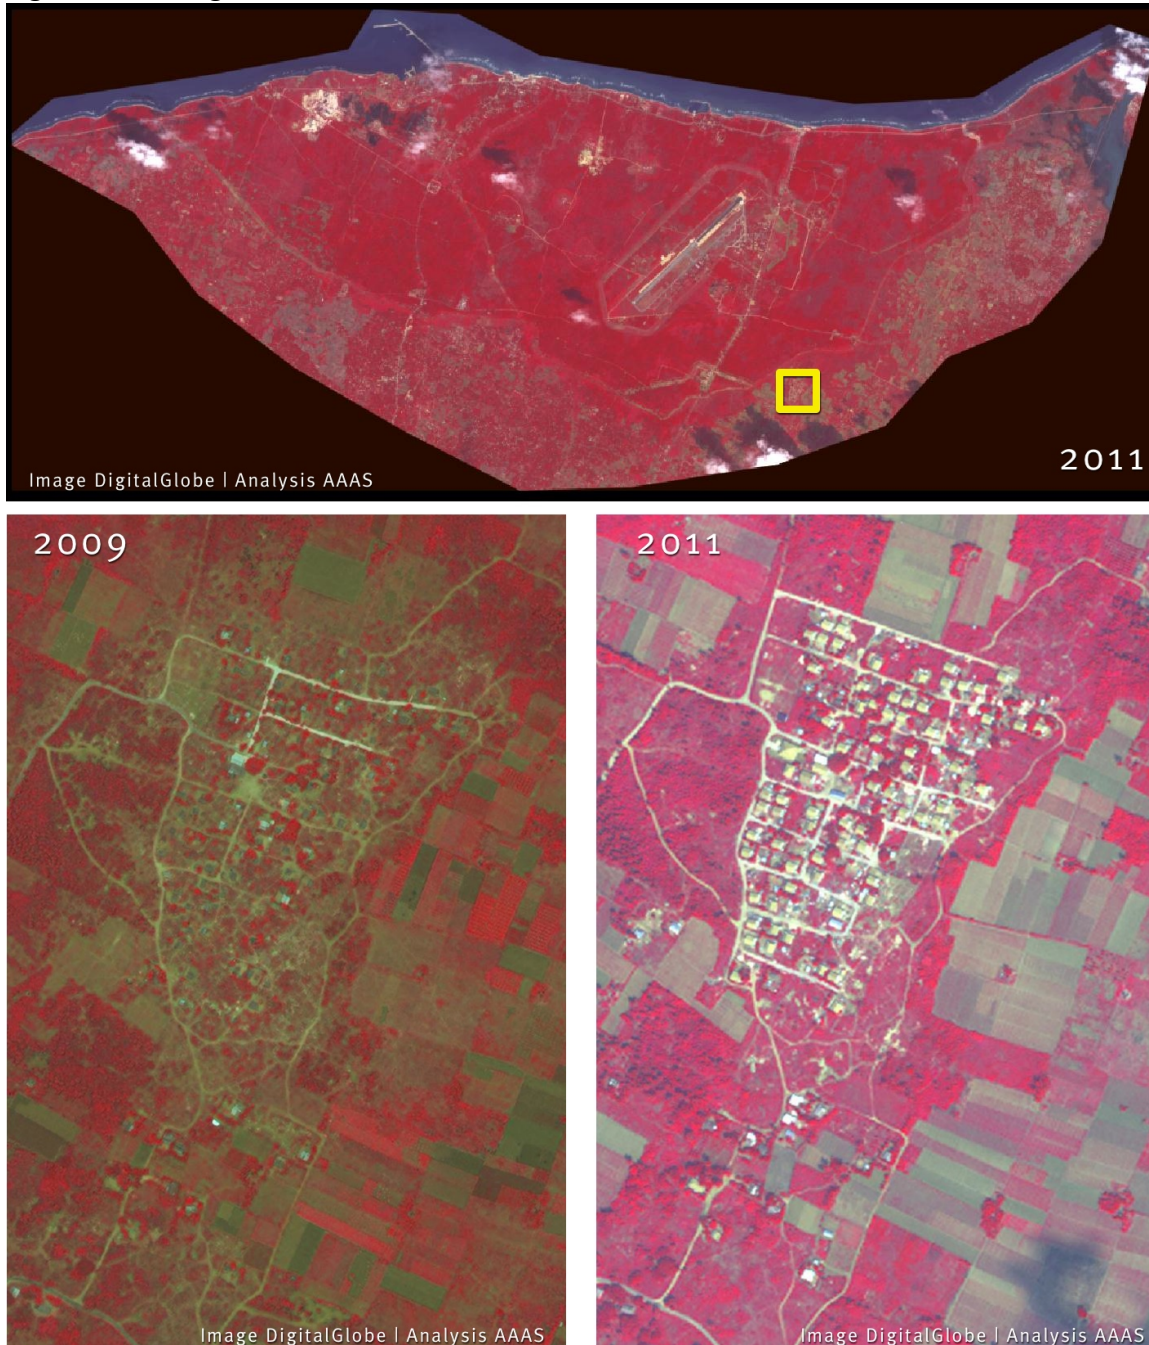
Figure 10: Changes outside the HSZ

Little change was seen immediately outside the bounds of the HSZ, with one exception. Between 2009 and 2011 an existing network of roads was developed into a small housing area, with approximately 77 large structures, the majority of which measure between 30-40m<sup>2</sup>.

*In the area just outside the HSZ, few changes were apparent, with the exception of the housing development shown above, which was largely constructed between 2009 and 2011. A total of 77 dwelling-sized structures are visible by 2011- only 3 of which were present in 2009. In addition, dozens of smaller structures, possibly sheds, are visible surrounding the structures. Images DigitalGlobe | Analysis AAAS. Location: 9.773N, 80.085E.*

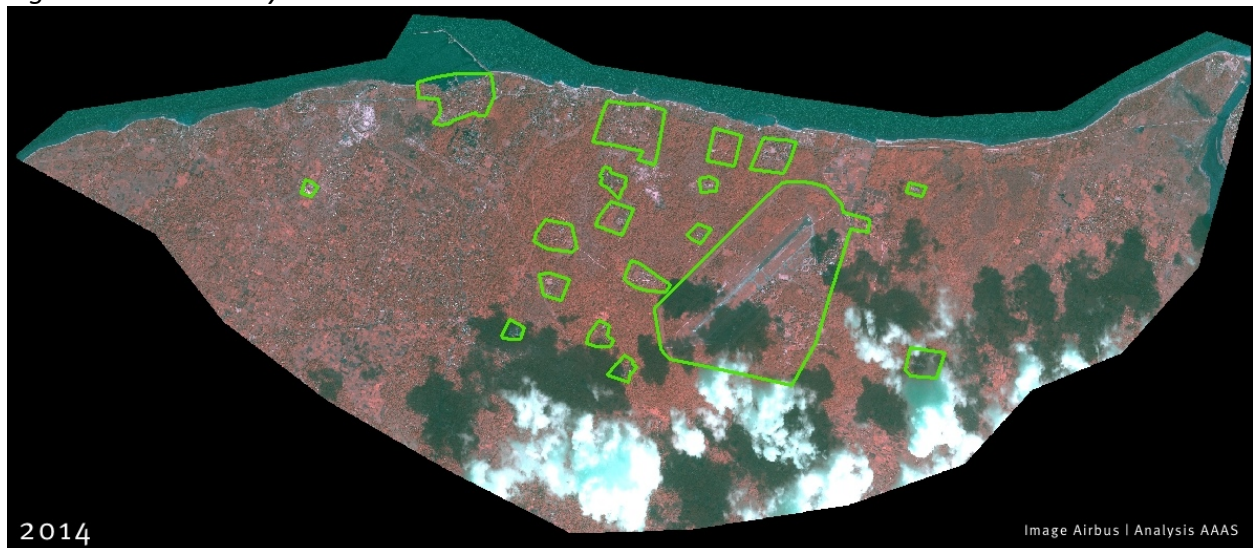
*Figure 11: Potentially Institutional Areas*

Although it is difficult to determine the purpose of structures based solely on satellite imagery, the presence of certain features can indicate institutional uses. These features include: fences and guard posts; large structures with similar building materials and dimensions; structures arranged in an orderly or planned fashion; a barrier (e.g. a road, forest, or field) separating the group of structures from other areas. However, it should be noted that the presence of these features does not necessarily indicate a public institution as businesses, factories, or other uses can be constructed in a similar fashion. Analyzing the 2014 image, 18 areas, containing 7.77 km<sup>2</sup> of land and primarily situated in the eastern two-thirds of the study area, were identified as potentially institutional (Figure 11).

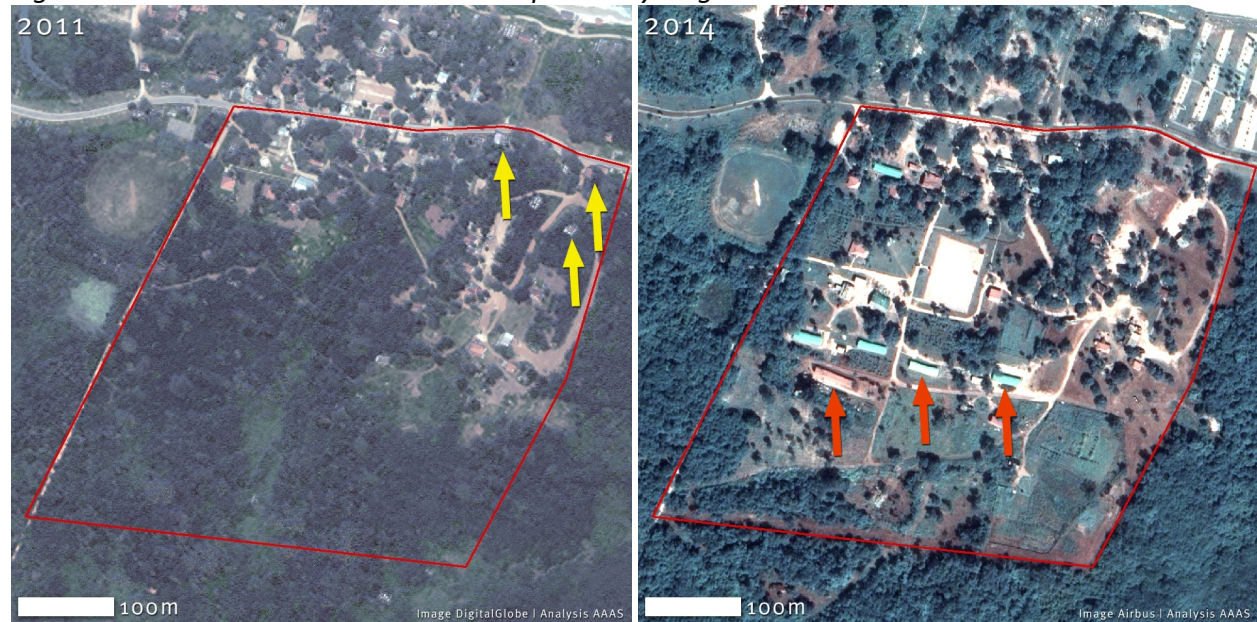
Figure 12: Small residential structures replaced by larger structures

The pattern of structure additions and removals varied between areas. In some areas, the type of structures removed differed from the new structures, as the removed structures were often small and similar in layout to residential structures, while the new structures were larger, warehouse type structures (Figure 12).

Between 2011 and 2012, several residential structures (yellow arrows) were removed from the area while multiple larger structures (red arrows) were constructed. Left Image: DigitalGlobe | Right image: Airbus Defense and Space | Analysis AAAS. Location: 9.8078N, 80.0726E.

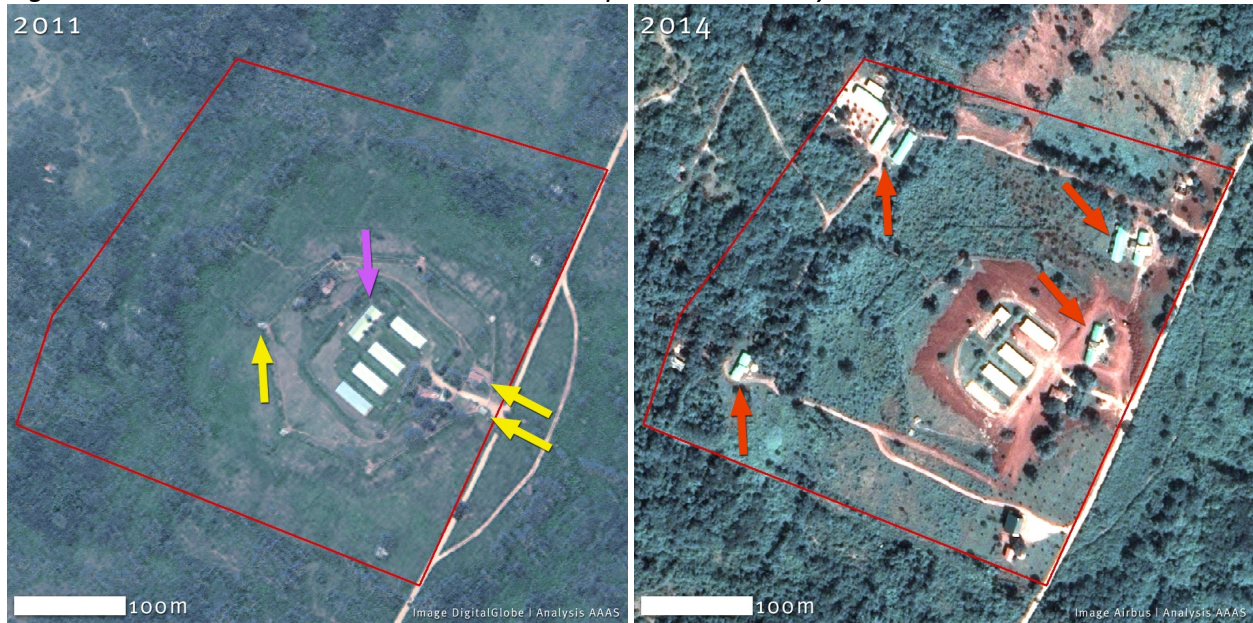
*Figure 13: Structures removed and added to a potential military installation*

In other areas, the type and layout of the structures indicated that the area was a military installation in 2011. In these areas, the removal of guard posts was observed between 2011 and

2014, as was the deterioration of existing structures. However, new, larger structures were constructed during the same time period (Figure 13). At a different area, marked as a hospital on the open source mapping platform wikimapia, a number of large structures are present in 2011.<sup>11</sup> By 2014, a complex of several additional structures was added (Figure 14).

*Between 2011 and 2014, several small structures (yellow arrows) were removed and a half of the roof of larger structure (purple arrow) was damaged. In the same time period, multiple larger structures (red arrows) were constructed. Left Image: DigitalGlobe | Right image: Airbus Defense and Space | Analysis AAAS. Location: 9.7995N, 80.0525E.*

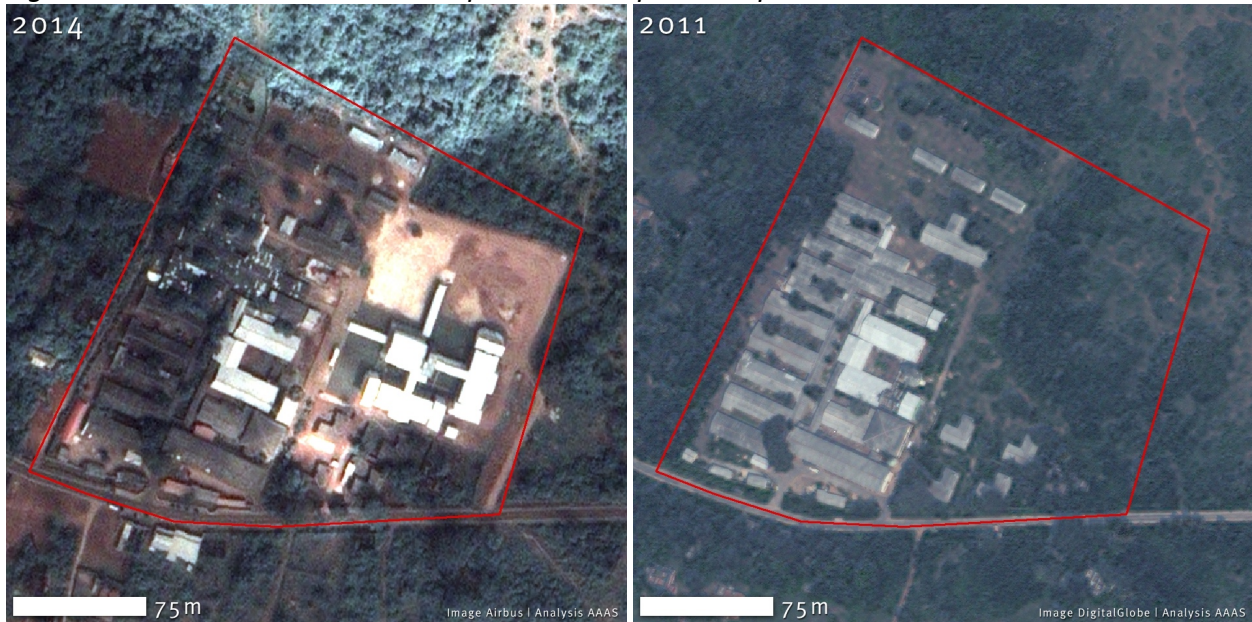
*Figure 14: New structures added to potential hospital complex*

*Between 2011 and 2014, a complex of several structures was added to a potential hospital. Left Image: DigitalGlobe | Right image: Airbus Defense and Space | Analysis AAAS. Location: 9.7852N, 80.0295E.*

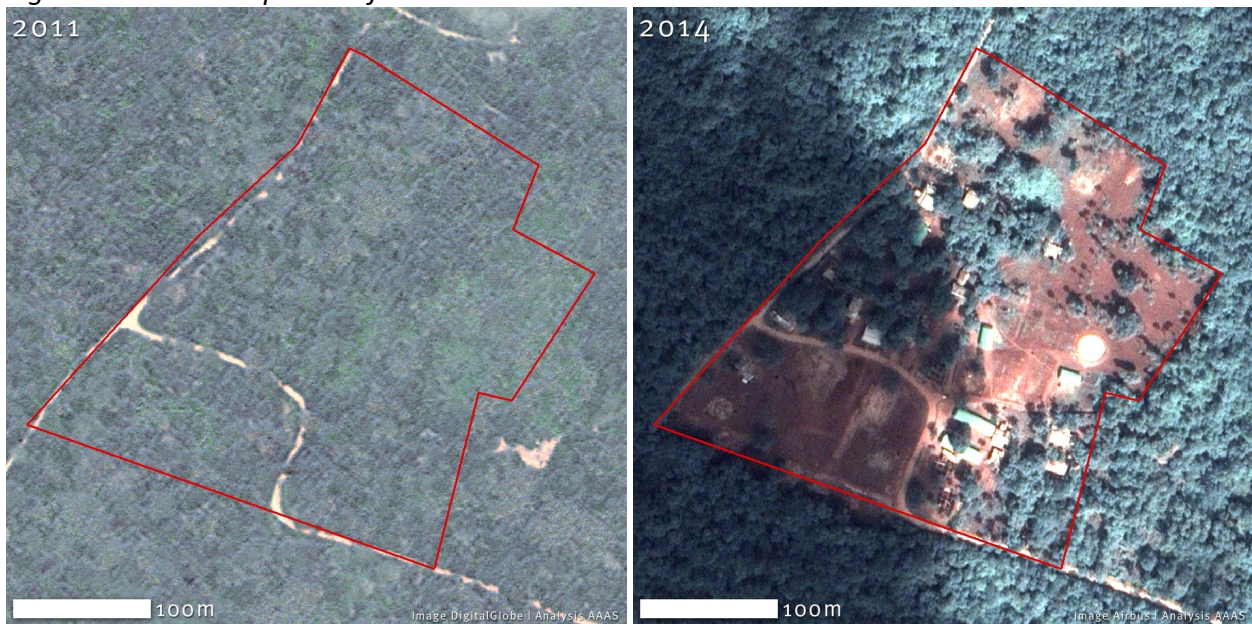
*Figure 15: New compound of structures*

In four of the 18 identified institutional areas, no structures were present in 2011. By 2014, several structures had been built in a manner indicating that the land was being put to an institutional use (Figure 15).

*Between 2011 and 2014, a complex of several structures was added to a previously unoccupied area. Left Image: DigitalGlobe | Right image: Airbus Defense and Space | Analysis AAAS. Location: 9.7804N, 80.0535E.*

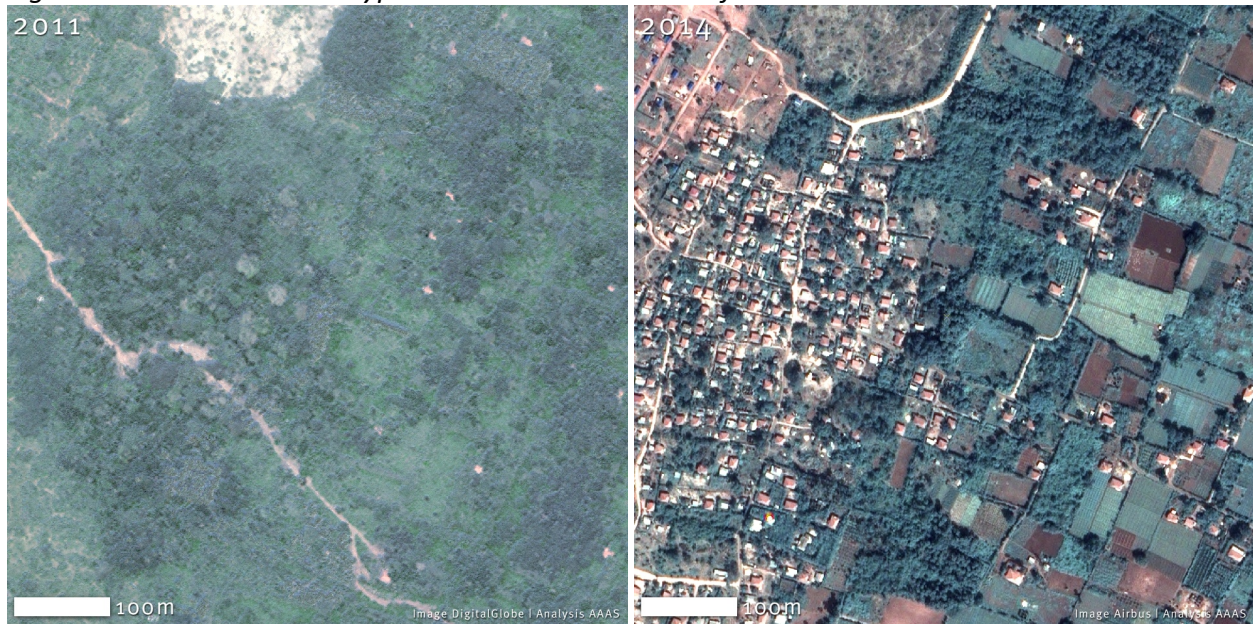
*Figure 16: New residential type structures near cleared fields*

These examples represent the types of changes that occurred at the 18 areas identified as potentially institutional. They include the removal of older structures and the addition of new, larger structures. In addition, an area that could be a hospital was expanded and four other areas were cleared to make space for new compounds. However, the vast majority of new construction occurred outside of these areas. Most of the construction was clustered in the western third of the study area. These structures ranged in size from 3x3 meters to 15x15 meters and tended to be clustered in a manner consistent with residential development. They were often bordered by cleared fields, indicating that agriculture was also occurring in the area (Figure 16).

*Between 2011 and 2014, large numbers of structures were added to the study area in a manner indicating that they were residential in nature. Left Image: DigitalGlobe | Right image: Airbus Defense and Space | Analysis AAAS. Location: 9.805N, 80.019E.*
